# **EXHIBIT 3**

## **(Part 2 of 2)**

*M.Delvin & Associates, Inc. Project No. 2009.01  
Diamante, Cabo San Lucas*

*Project Review and Site Visit Report  
November 2015*

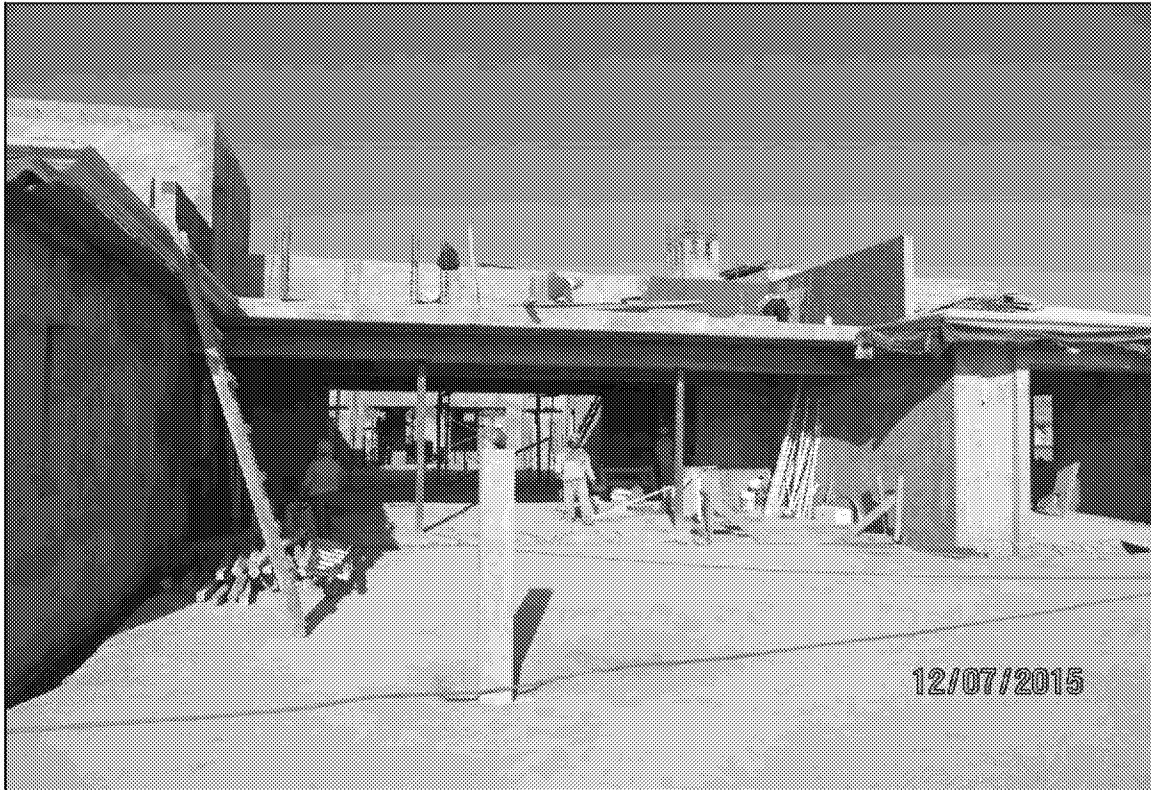
**Photograph 47:** GV 47: The walls and columns of the second floor balcony deck are being constructed.

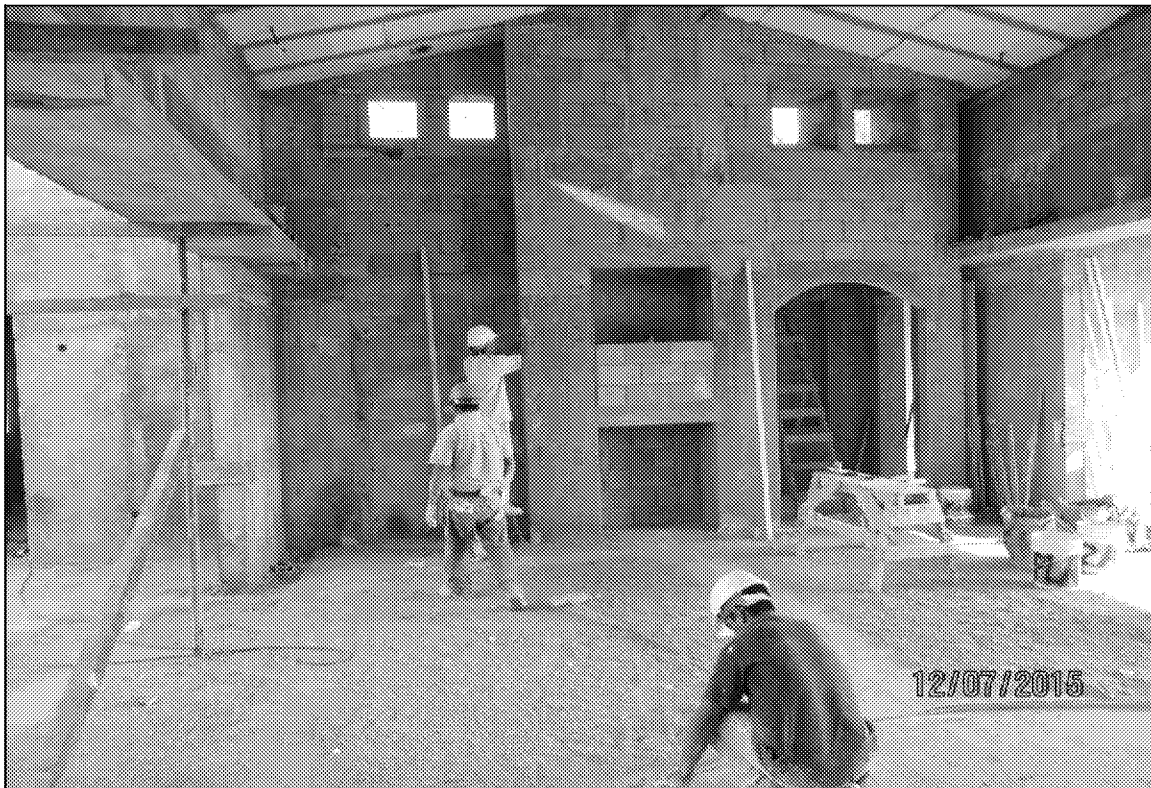
**Photograph 48:** GV 47: Building structure construction is relatively complete but interior plaster coat application has not started.

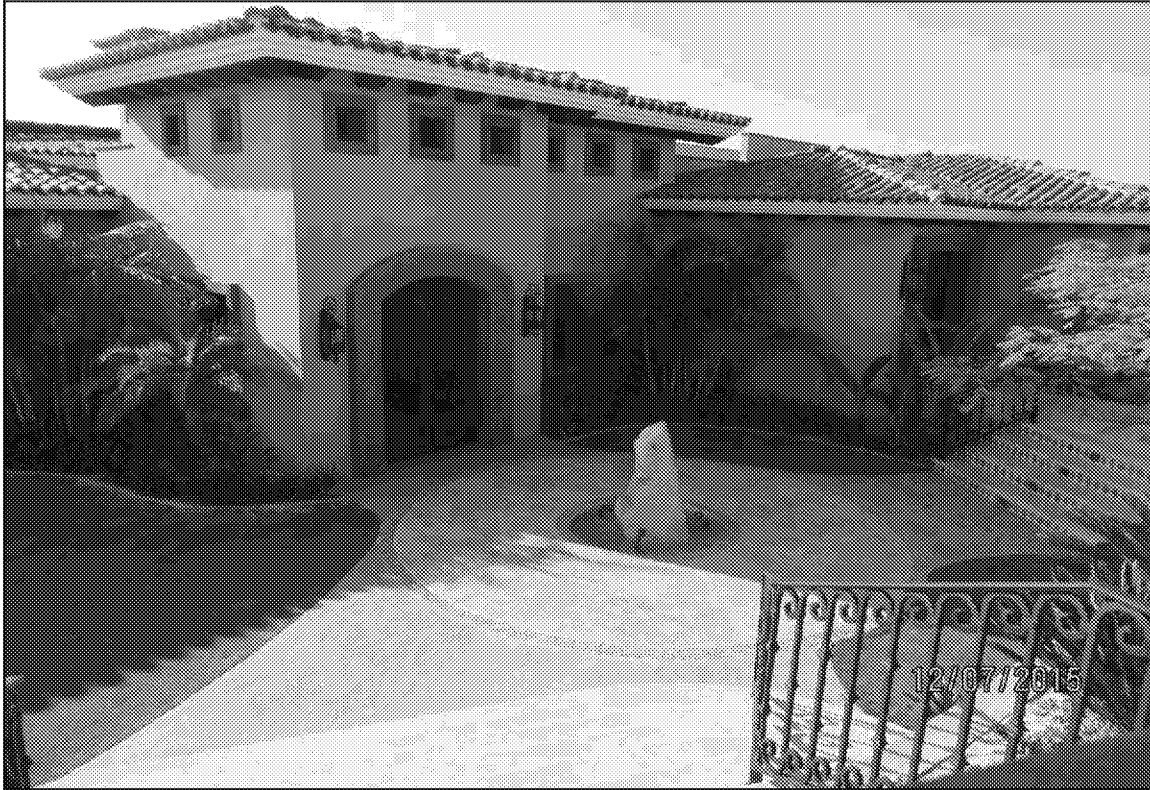
**Photograph 49:** Sunset Hill Lot 55: The home is complete and waiting on final furniture delivery.

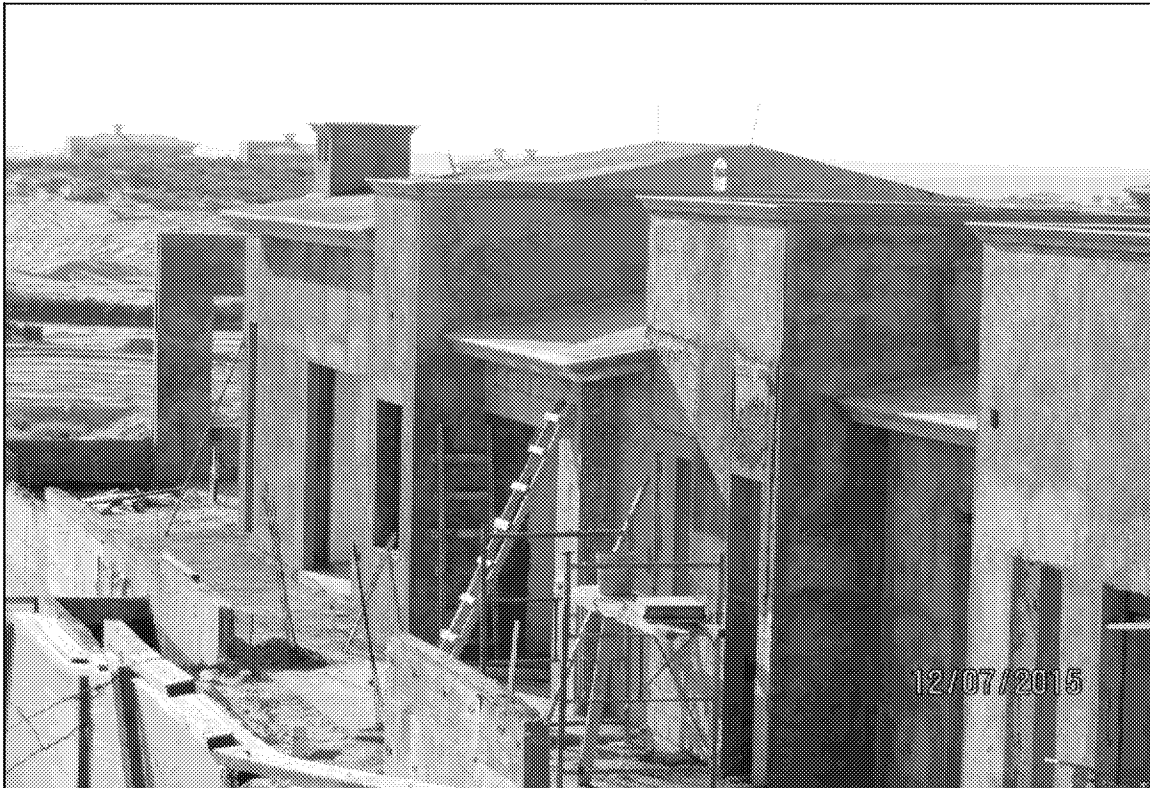
**Photograph 50:** Sunset Hill Lot 59: This private home construction project is making slow progress. Building structure and some of the exterior cement plaster coating is complete.

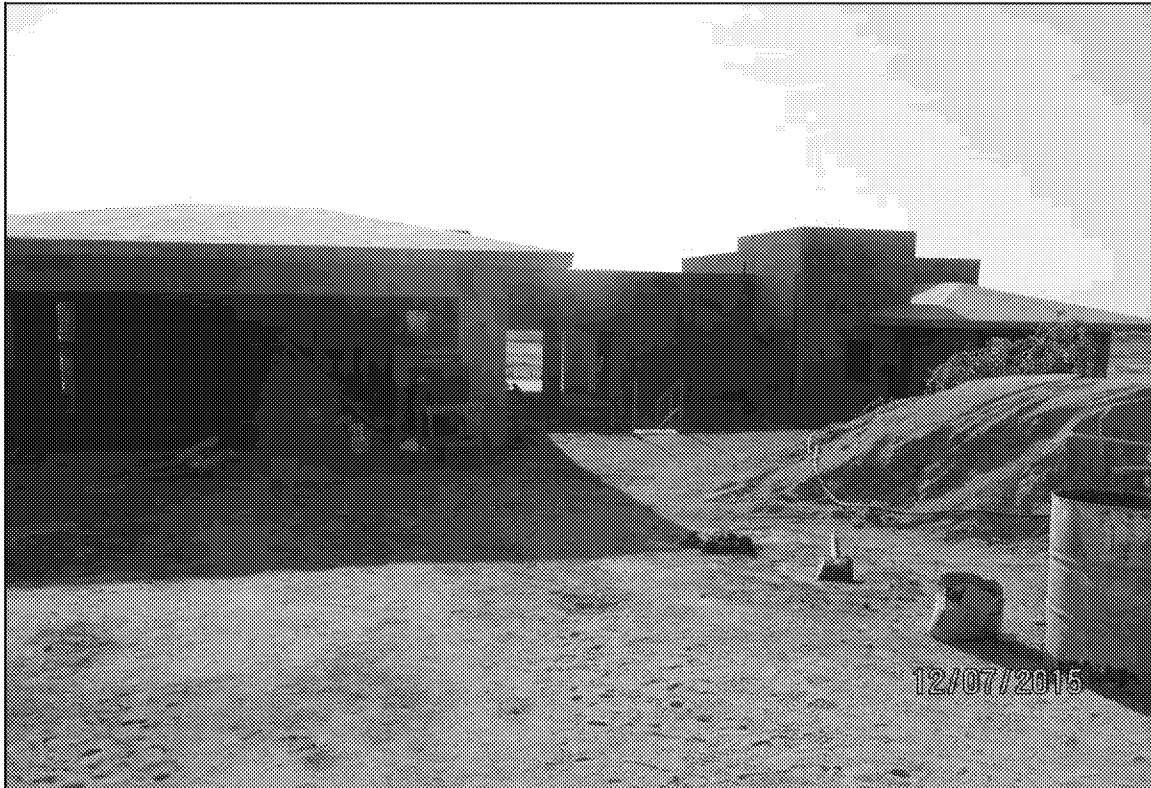
**Photograph 51:** Sunset Hill Lot 23: The construction on this home has resumed. The site was cleared of over-growth and the home is being prepared for application of exterior finishes.

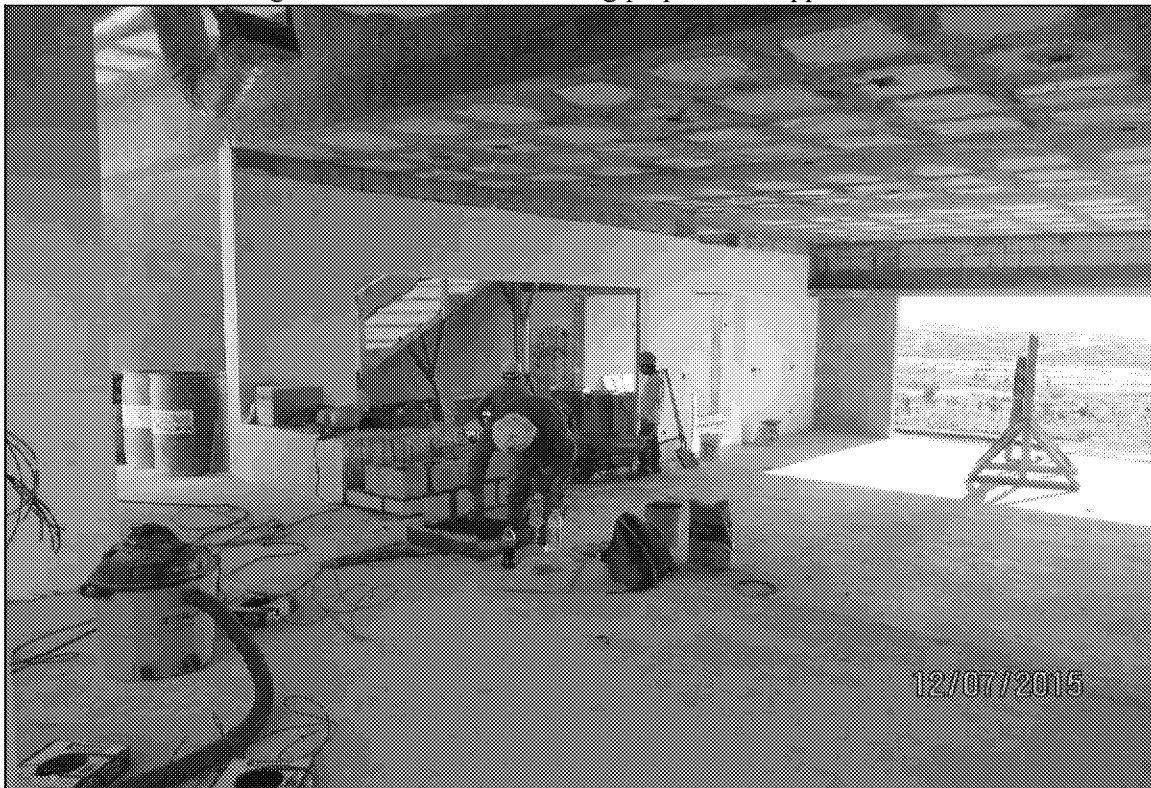
**Photograph 52:** Sunset Hill Lot 23: Minor changes are being made to the interior walls and lime-cement plaster coating is being applied.

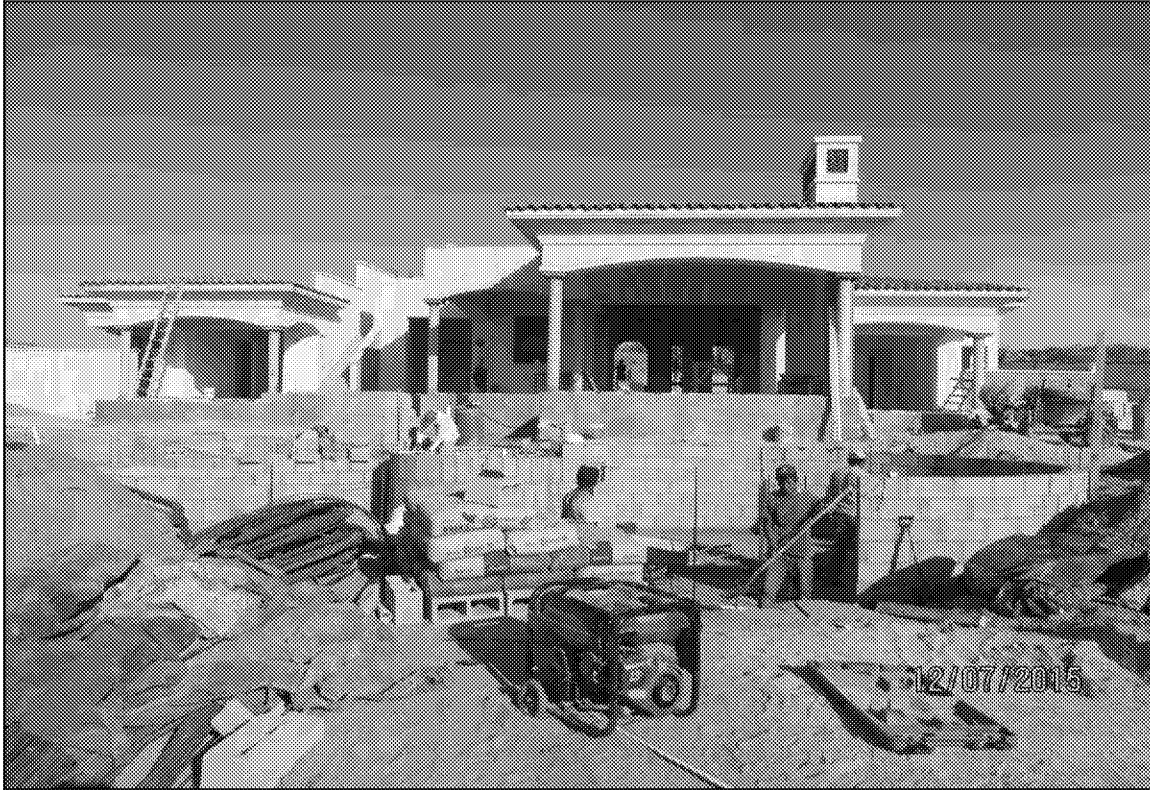
**Photograph 53:** Sunset Hill Lot 73: Good progress is being made on this private home construction project, with roof tile placement complete.

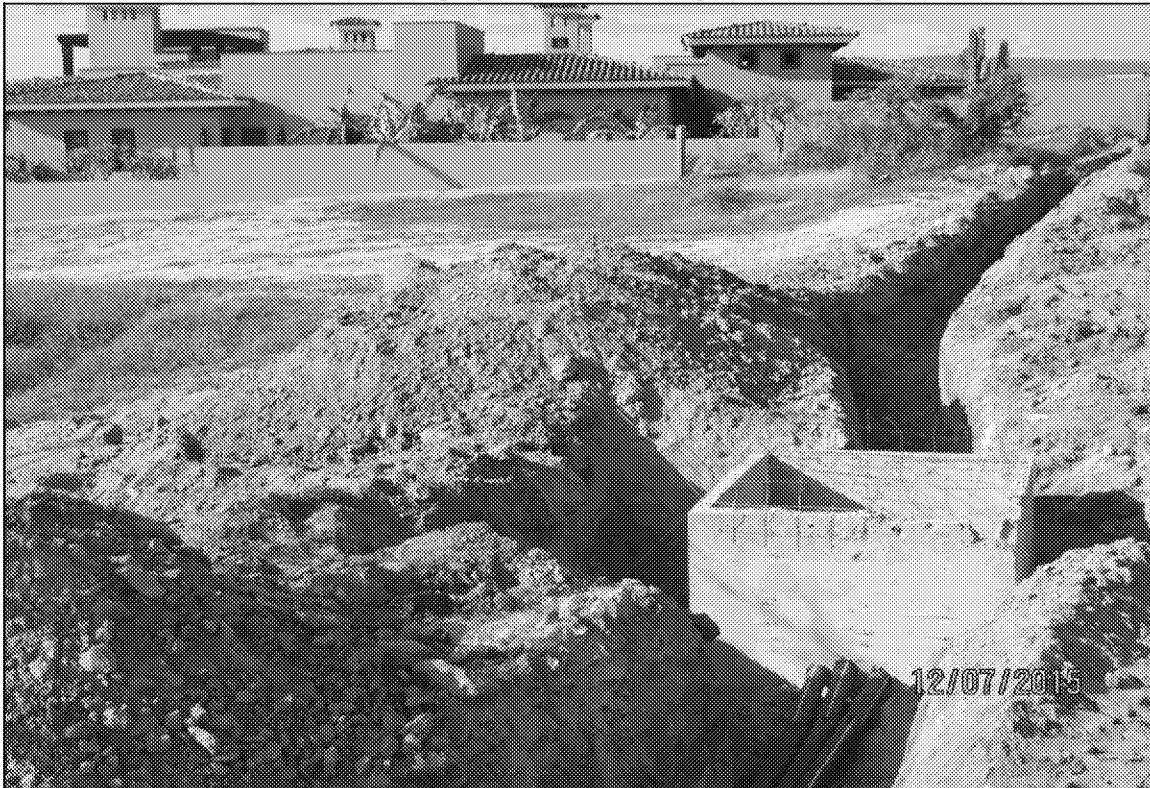
**Photograph 54:** Sunset Hill Infrastructure: Conduits and pull boxes are being placed for the power line construction extending to Lot 73.

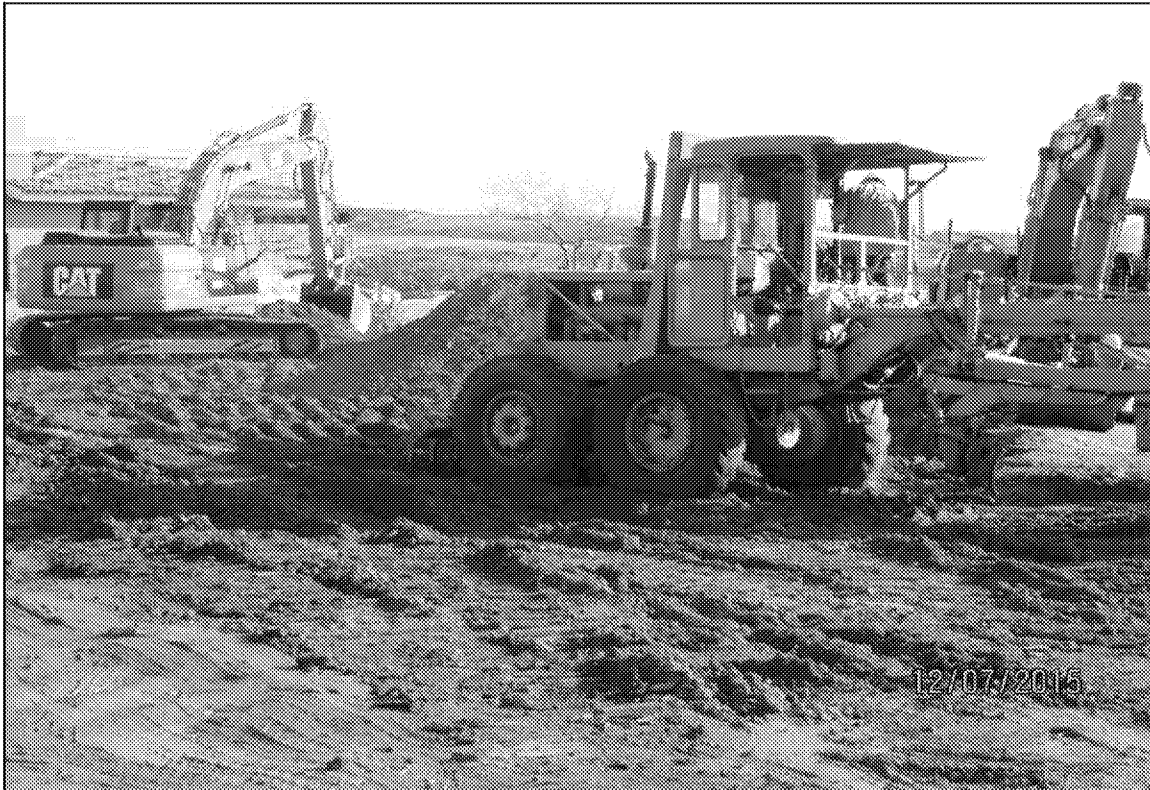
**Photograph 55:** Casitas Site: Earthmoving operations are underway to re-configure the building pads for the new lot layout.

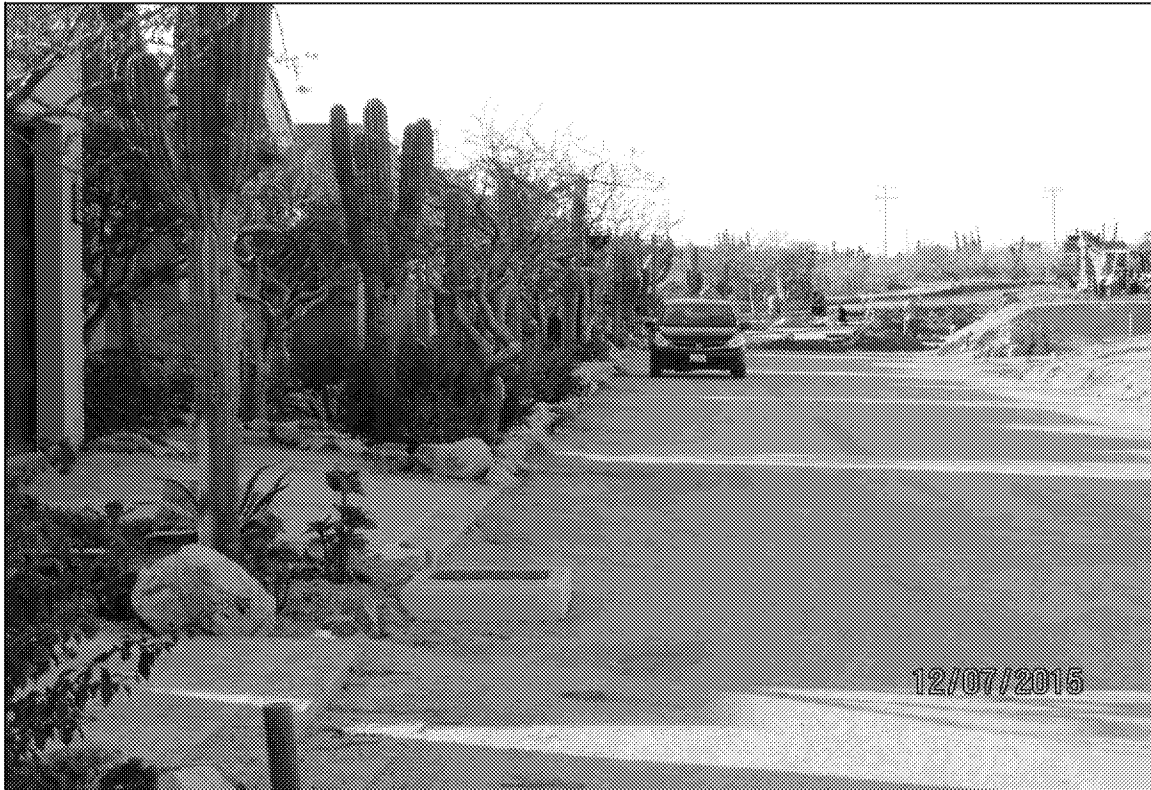
**Photograph 57:** Casitas Site, main road: The road being used by homeowners is built with compacted soil and gravel and until further improvements are made, no asphalt coating will be applied.

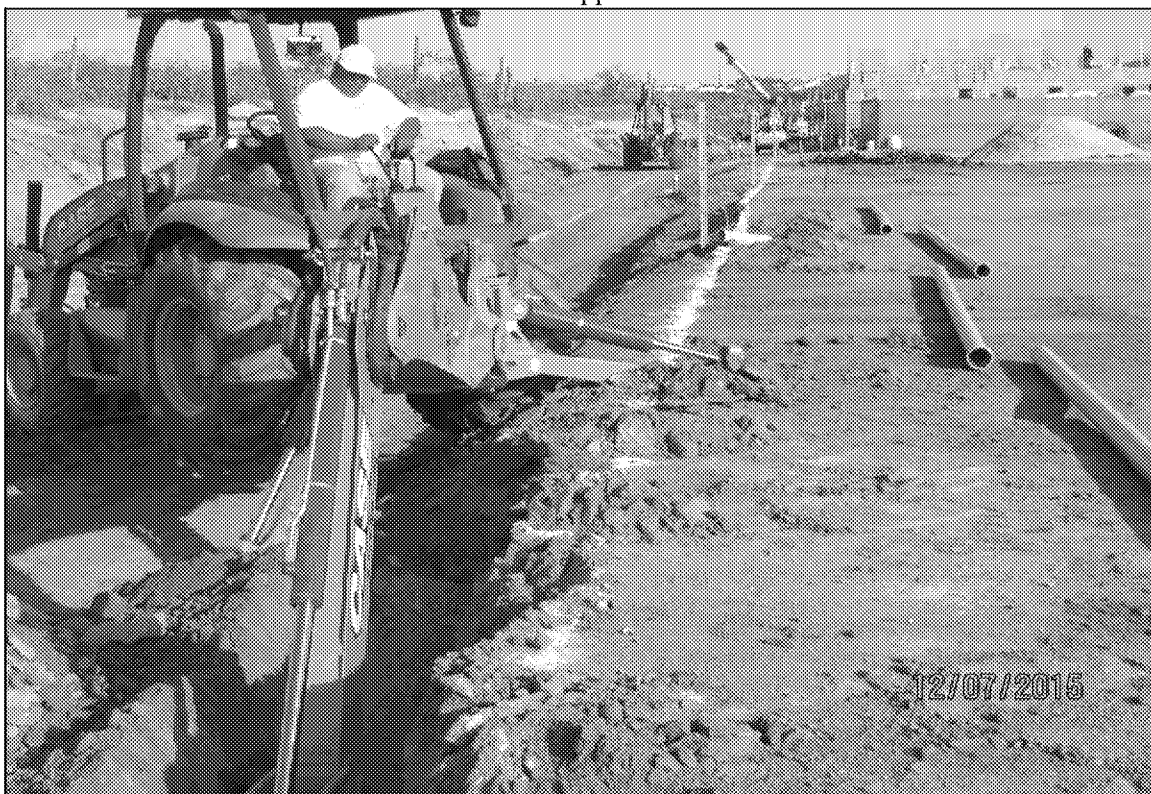
**Photograph 58:** Casitas Site: Water line construction is underway for the upper tier of homes on Lots 18 through 22.

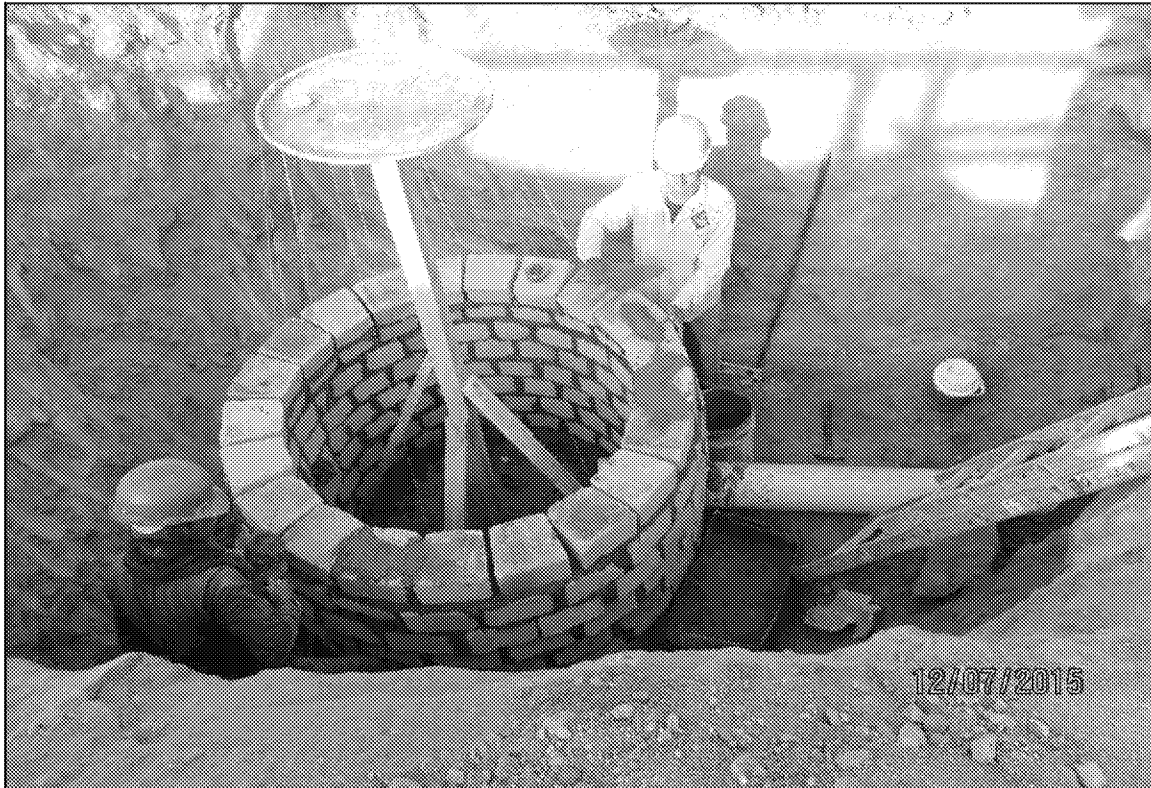
**Photograph 59:** Casitas Site: Construction of sewer line manhole which will service the upper tier of homes.

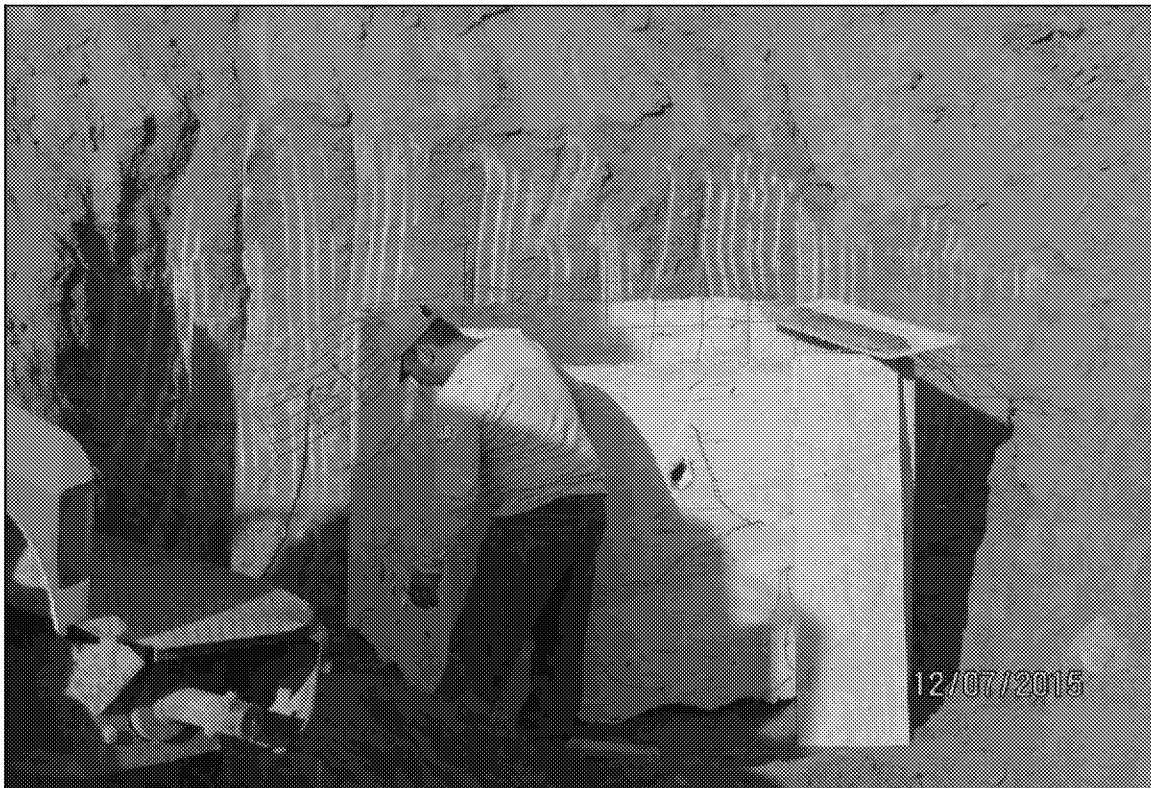
**Photograph 60:** Casitas Site: A utility vault has been constructed and conduits for power lines are being installed for the upper tier of homes.

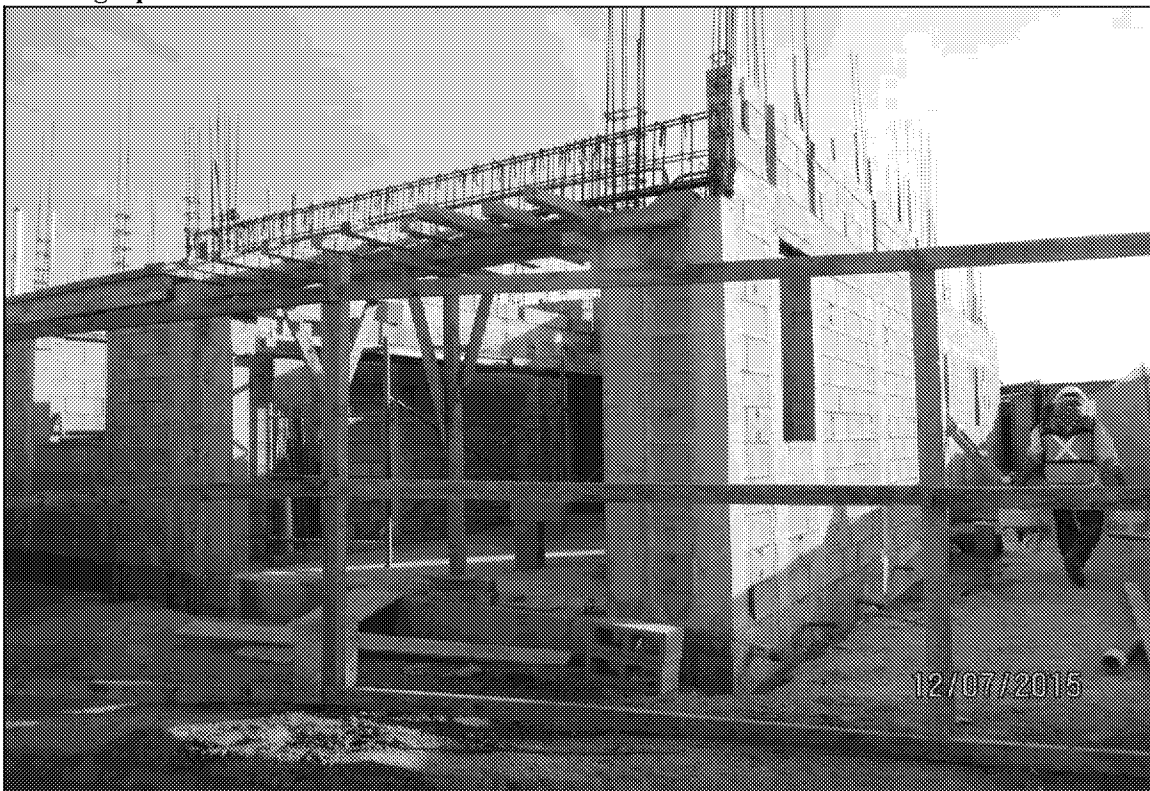
**Photograph 62:** Casitas Home Lot 18: The concrete slab and foundations are complete and exterior CMU wall construction is underway.

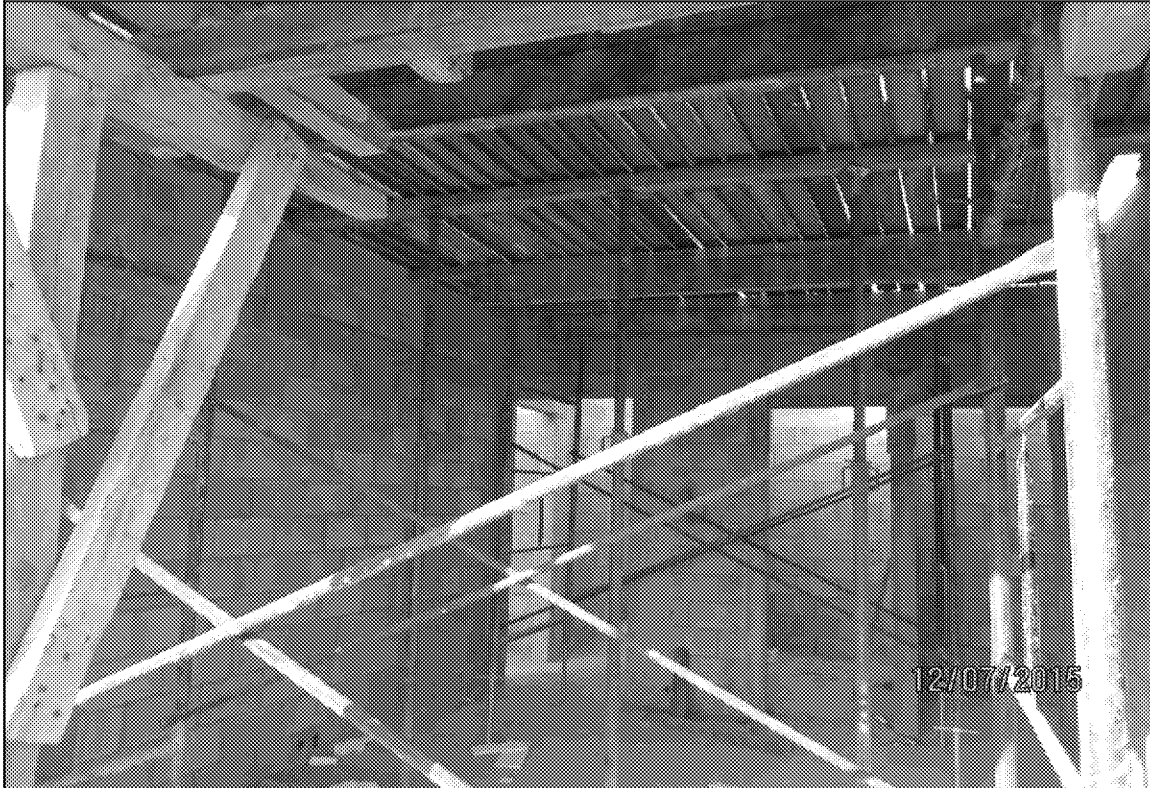
**Photograph 63:** Casitas Home Lot 18: Forms are placed for roof structure construction.

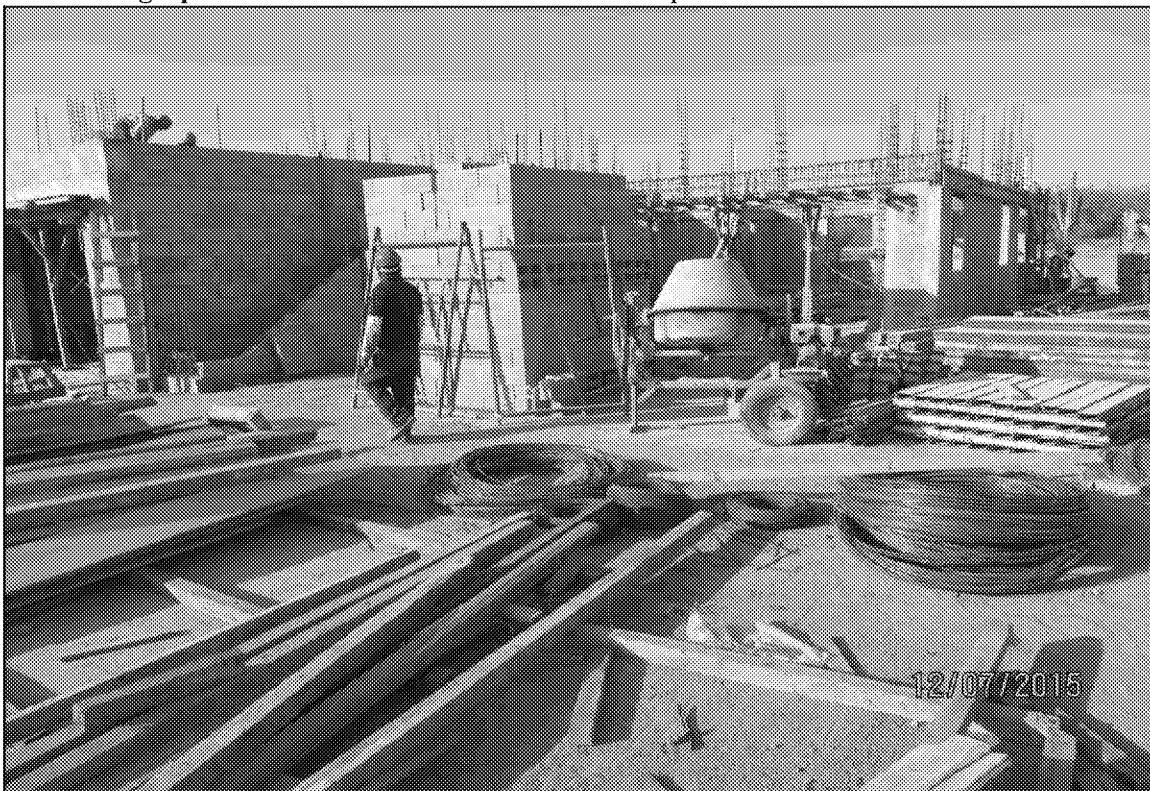
**Photograph 64:** Casitas Home Lot 18: Building material and equipment is stored on the adjacent site as a staging area for the construction project.

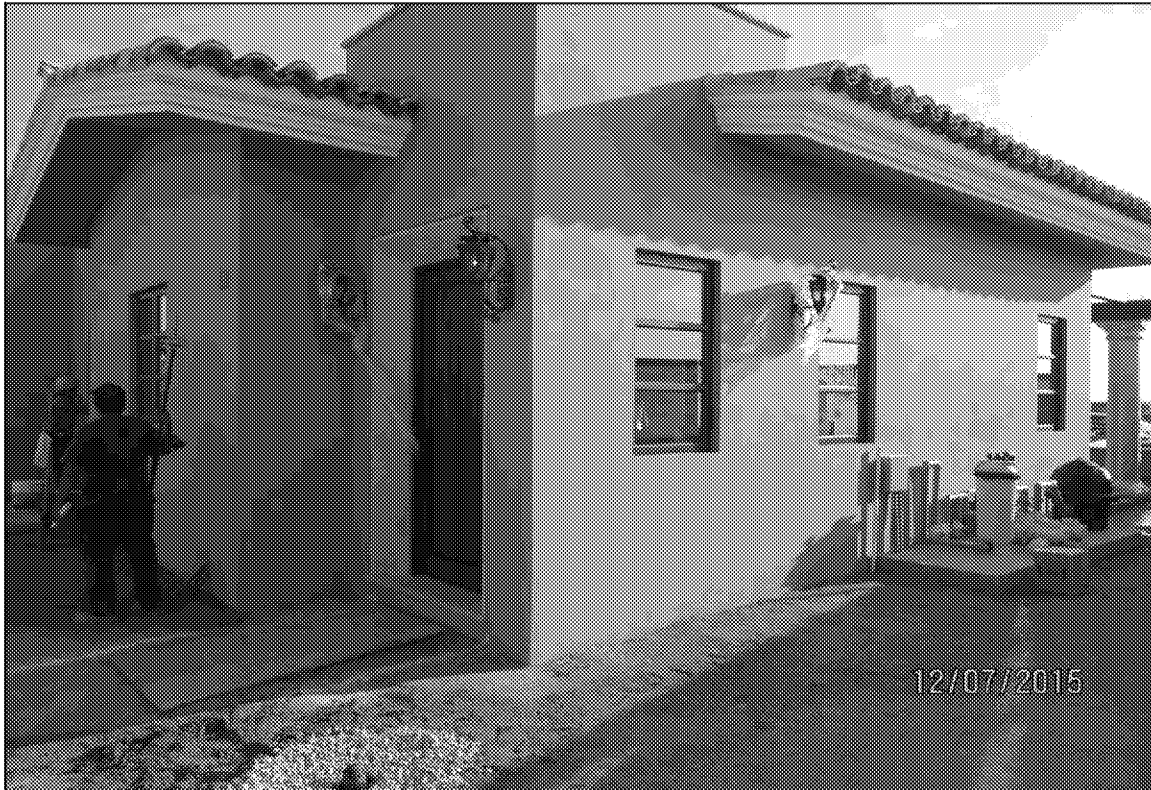
**Photograph 65:** Casitas Lot 20: The exterior finishes are relatively complete.

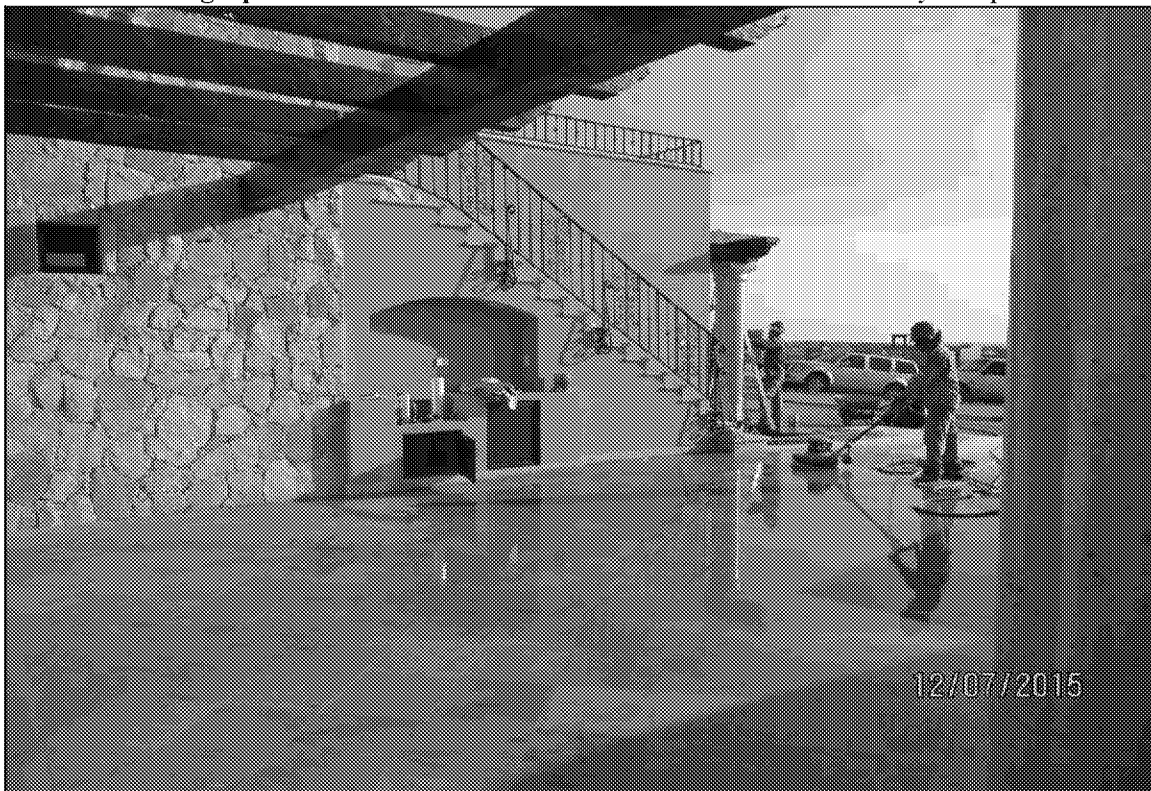
**Photograph 66:** Casitas Lot 20: The final sanding of the patio stone tile is underway. Other exterior finishes are relatively complete. The outdoor grill and cooking area has not yet been placed.

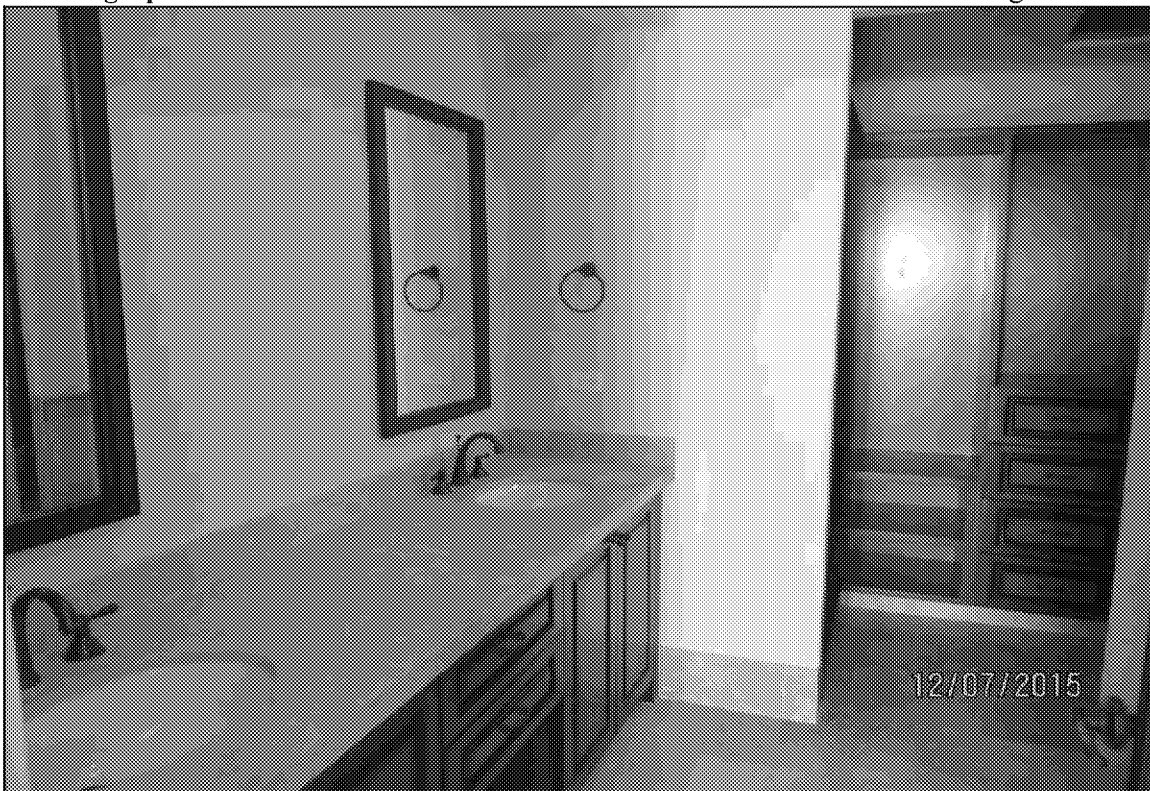
**Photograph 68:** Casitas 20: Bathroom vanities, countertops, sinks and fixtures are complete and closet shelving is complete.

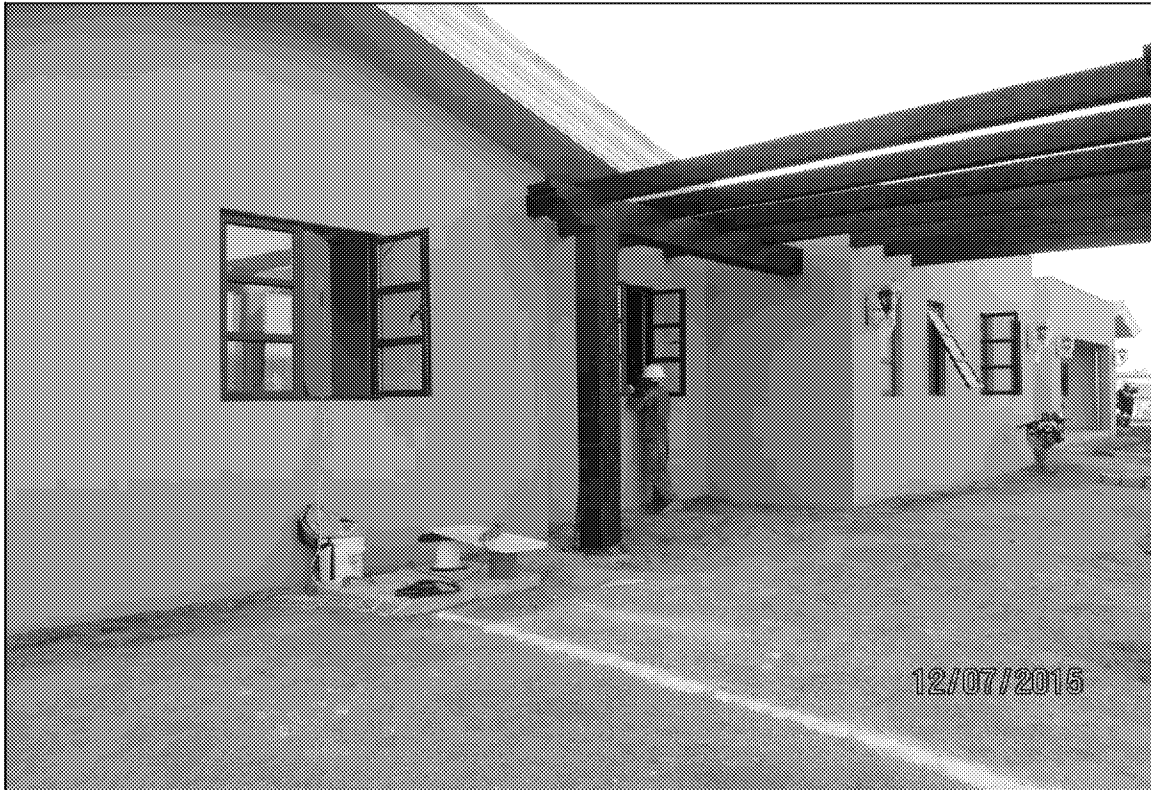
**Photograph 69:** Casitas 21: The exterior finishes including the wood trellis over the future driveway are relatively complete.

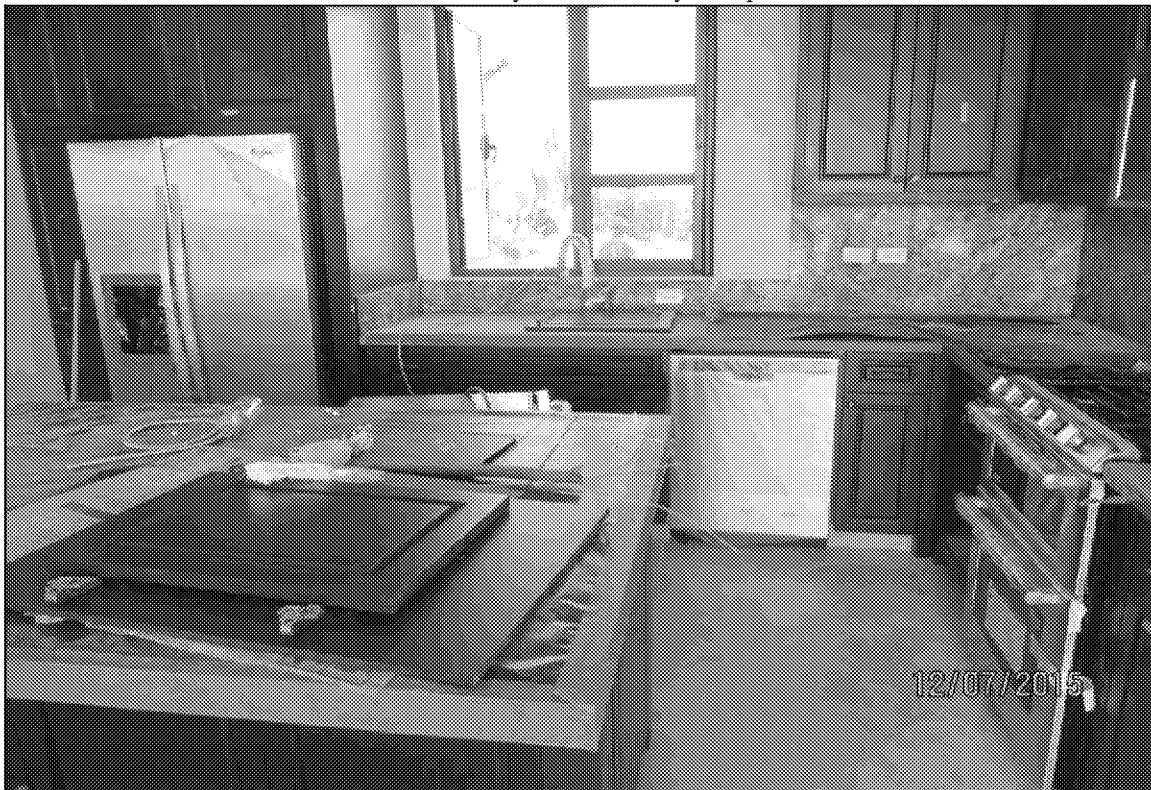
**Photograph 70:** Casitas 21: Kitchen cabinets, countertops, and appliances have been installed.

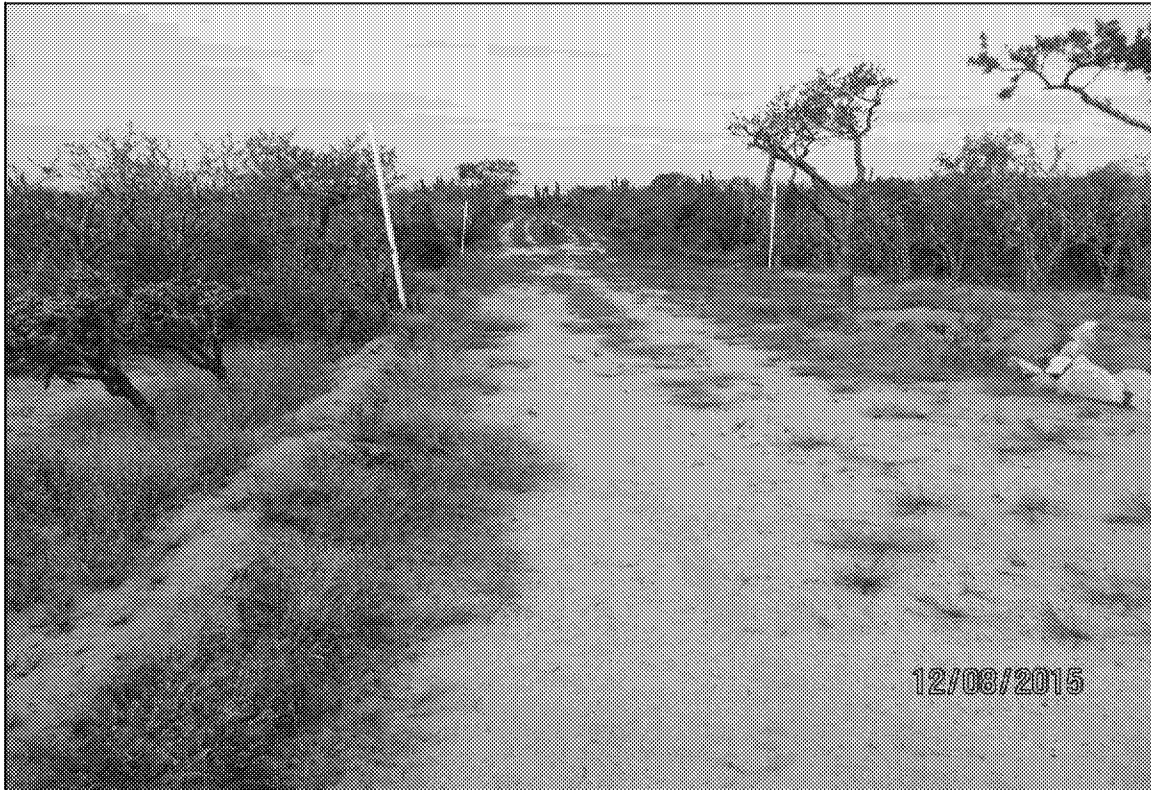
**Photograph 77:** Ocean View Estates: No work has been done on the site roads since original rough-in construction and weeds are encroaching. These will be cleared for the upcoming tourist season.

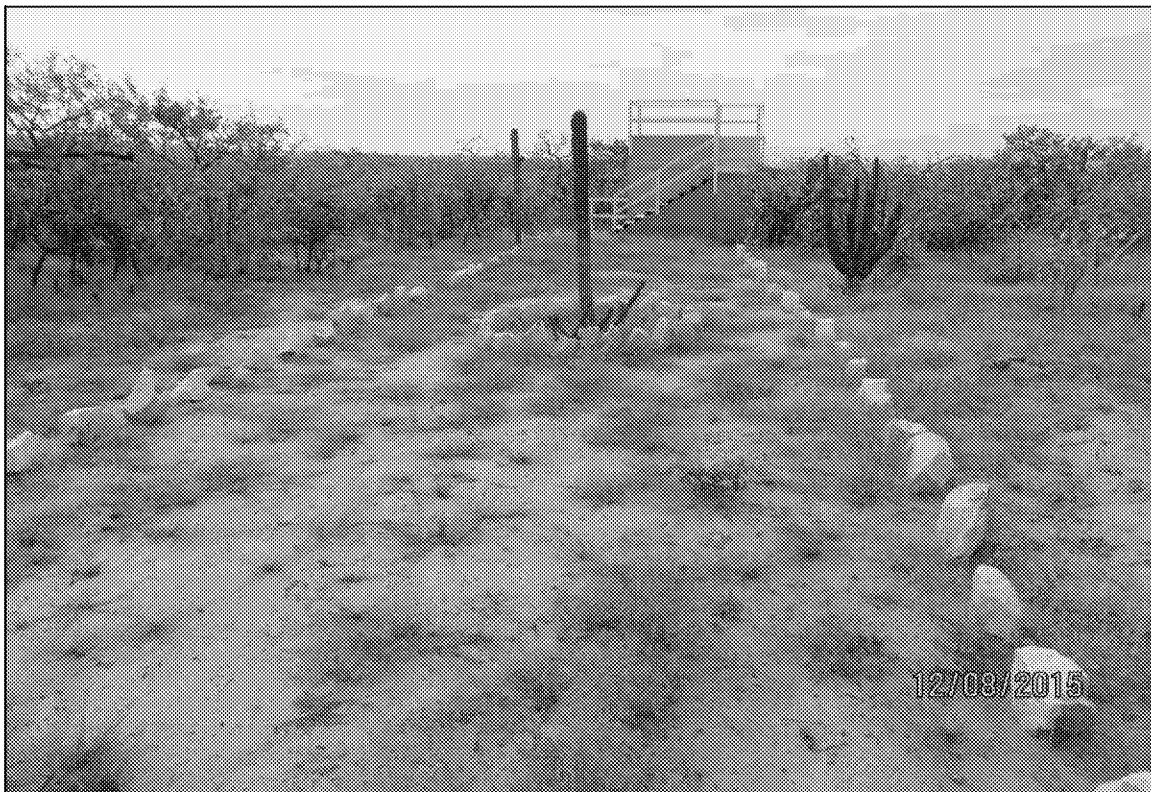
**Photograph 78:** Ocean View Estate Lot viewing platform: The site is slightly over-grown with weeds and will be cleared for the upcoming tourist season.

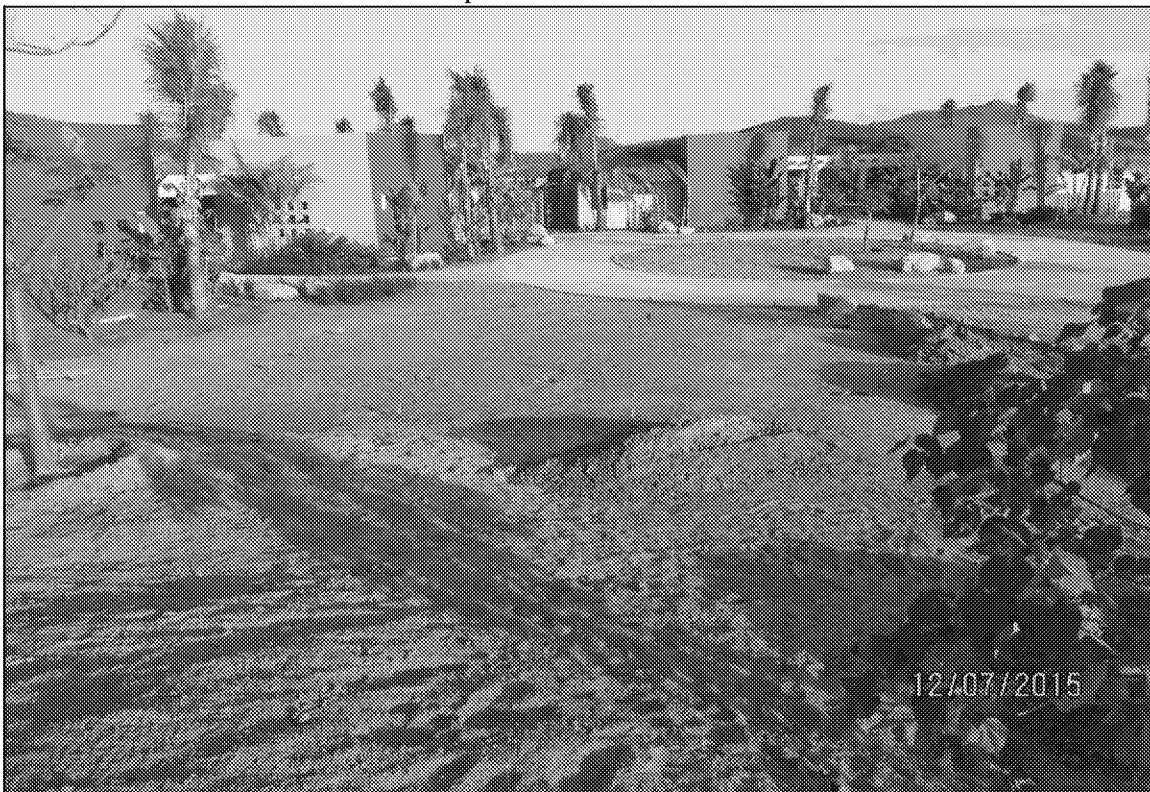
**Photograph 80:** Resort Site Work: The cart path immediately in front of Bungalows 7 and 8 was paved with colored concrete pavement.
